ELVITA

Service Bulletin
230612CTM3714V

Preventive action – replacing main PCB.

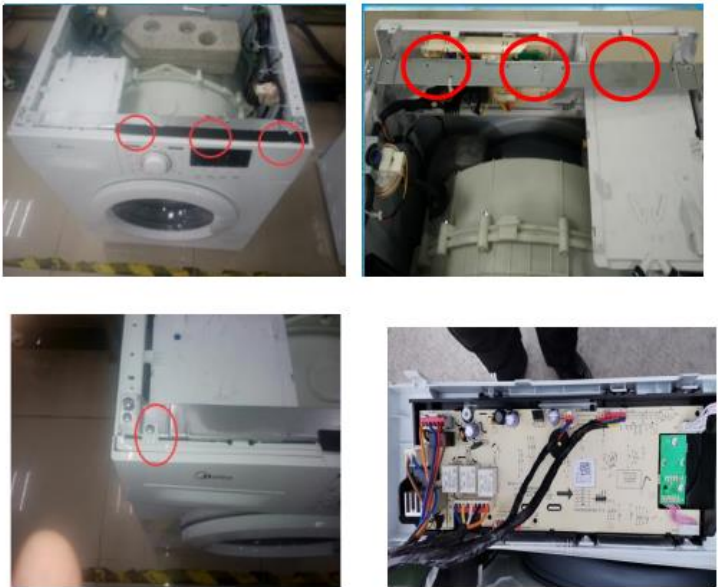
3. Undo the control panel and PCB

- I. Departing the top cover
- II. Draw out the detergent drawer.
- III. Loosen two screws fit on the control panel .
- IV. Loosen two screws fit on the control panel.
- V. Take out the control Panel inclined from the panel .
- VI. Extract the cycle select knob
- VII. Pull out the wire and press the buckle to take out the PCB.

1. Replace the main PCB. Make sure all connections are properly fitted.

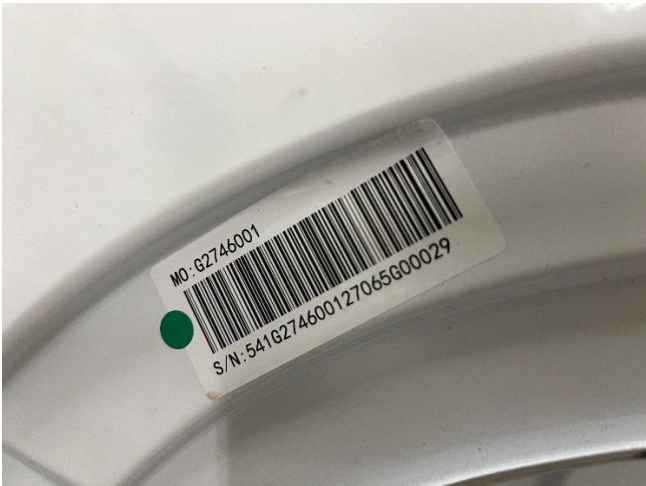
2. Put the green sticker on the corner of the serial number label. This is mandatory and is done to make visible that this action has been carried out on the device
